ROYAL AIRCRAFT ESTABLISHMENT

Technical Report 85059

**A COMPARISON OF THE FATIGUE
PERFORMANCE OF WOVEN AND
NON-WOVEN CFRP LAMINATES**

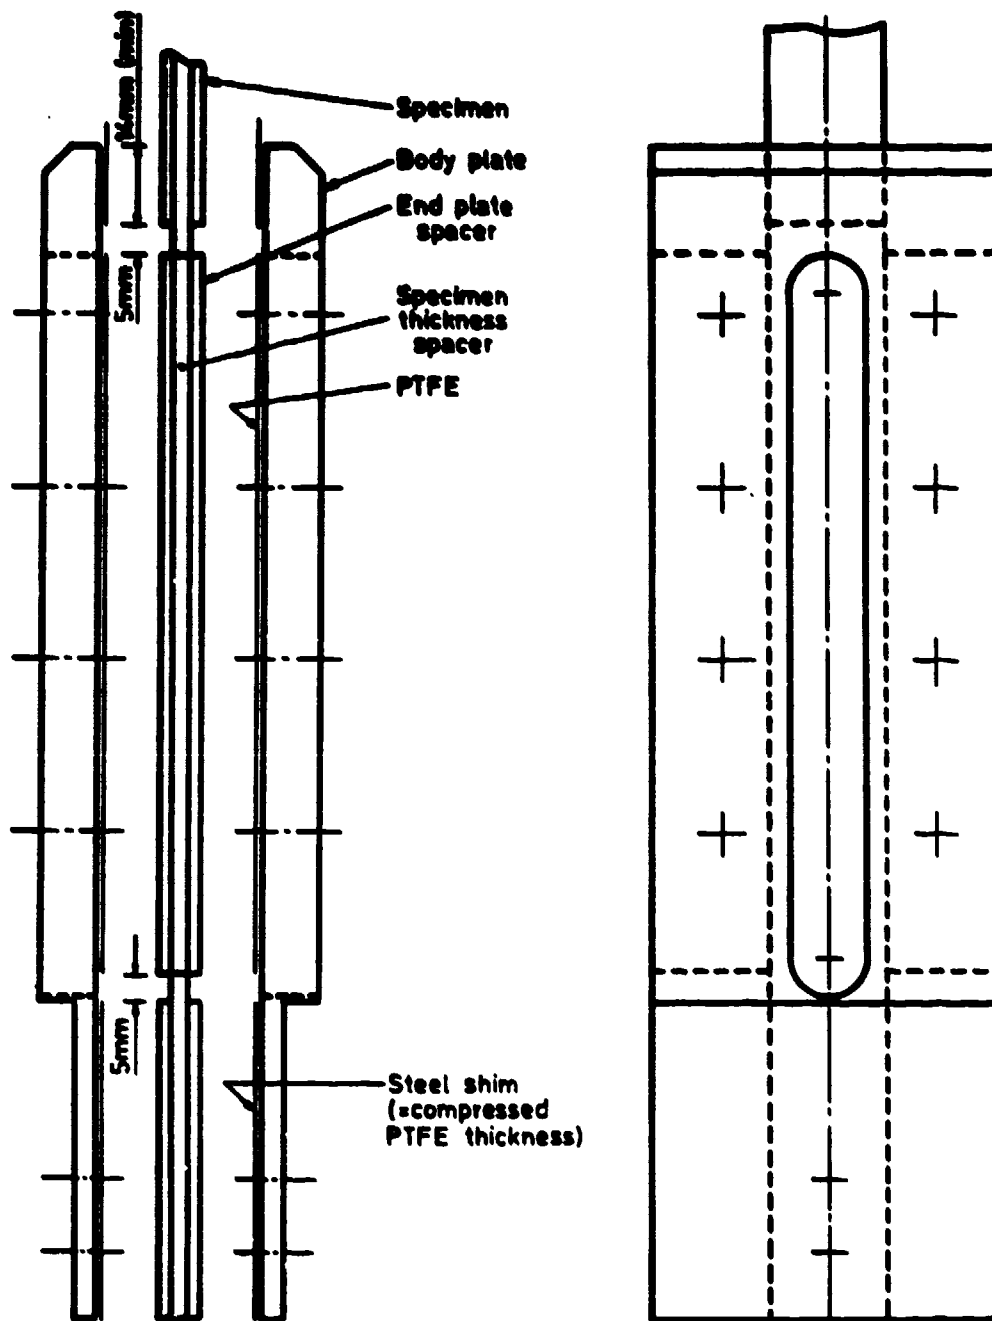
Fig 1 Anti-buckling guide used to support coupons during compressive testing

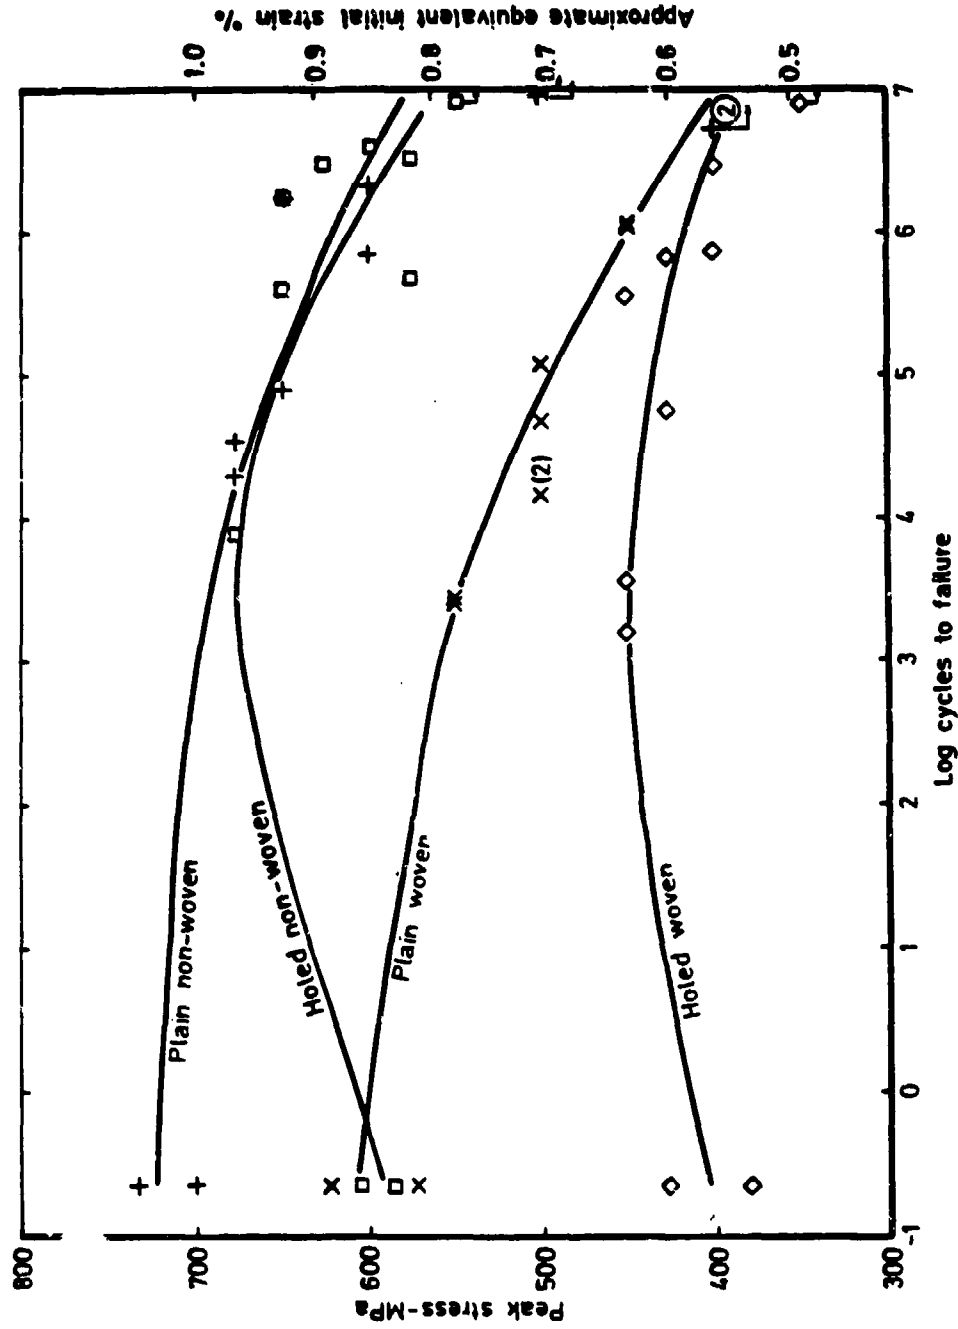
Fig 2 S-N plots of zero-tension fatigue data for layup A (0,90).
Horizontal arrows denote run-outs

In the tensile fatigue loading of the (0,90) material (lay-up A), both plain non-woven and woven coupons suffered losses in strength with increasing numbers of fatigue cycles, but the effect was more pronounced in the woven material (Fig 2). Thus the static strength difference observed between the non-woven and woven material, due to a combination of lower fibre volume fraction and greater fibre distortion in the woven material, became greater in fatigue loading. Optical microscopy and ultrasonic C-scanning revealed extensive transverse cracks across the 90° layers and delamination between layers, increasing with increasing numbers of fatigue cycles. In the non-woven material this effectively uncoupled the 90° layers from the 0° layers and the behaviour was then typical of unidirectional CFRP in fatigue. In the woven material however, the 90° tows remain interwoven with the 0° tows and thus continue to exert a stress concentrating influence on them. The C-scan revealed areas of damage at tow crossovers, probably involving 0° tow degradation, and this resulted in a steeper S-N curve than observed in the non-woven material.

The strength of the (0,90) holed coupons, both woven and non-woven, increased at first with increasing numbers of fatigue cycles, but fell after greater numbers of cycles (Fig 2). The initial increase in strength was only possible because of the manner in which the fatigue tests were performed, which involved the gradual increase of peak load from zero to maximum over about 2000 fatigue cycles. There was sufficient cyclic loading to develop damage zones around the holes and relieve the stress concentration leading to initially greater strengths. After only 10000 cycles the holed non-woven coupons were as strong as the plain coupons, but the holed woven coupons never quite attained the strength of the plain coupons, even after 10 million load cycles. Ultrasonic C-scanning revealed the development of longitudinal splitting and 0/90 delamination around the holes, this being the cause of the initial reduction in notch sensitivity. This was more apparent in the non-woven material, explaining why this material recovered more of its plain strength than the woven material. In the holed woven material the 90° tows can never become completely uncoupled from the 0° tows, because of their woven nature, and they continue to exert a stress concentrating influence at the tow crossover points. Indeed these points were the site of additional damage observed experimentally.

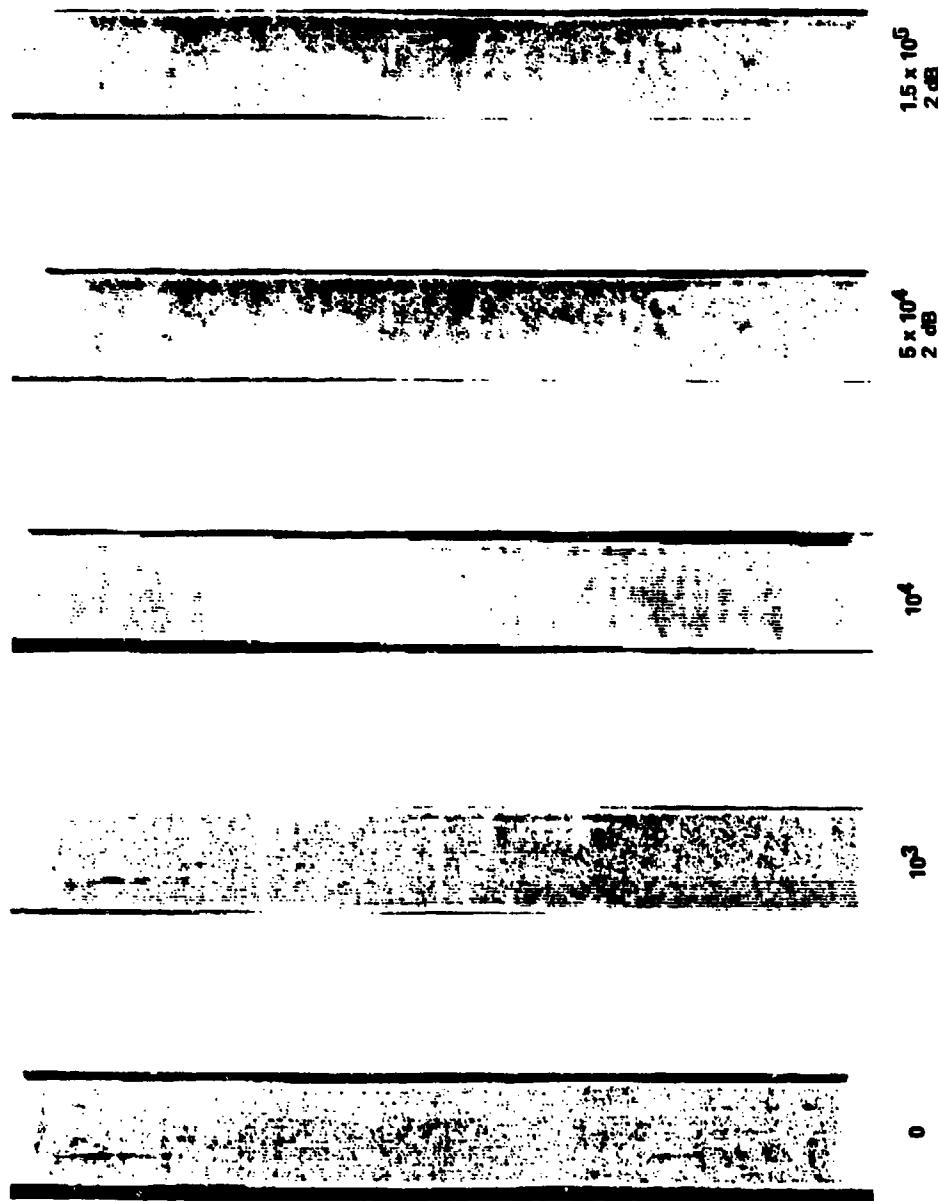
Fig 3 Ultrasonic C-scans of a non-woven plain coupon with layup A (0.90) tested in tensile fatigue at the stress level giving a mean life of 100000 cycles. Left to right, scans after: 0 cycles at 1 dB steps, 1000 cycles at 1 dB steps, 10000 cycles at 1 dB steps, 50000 cycles at 2 dB steps, 150000 at 2 dB steps

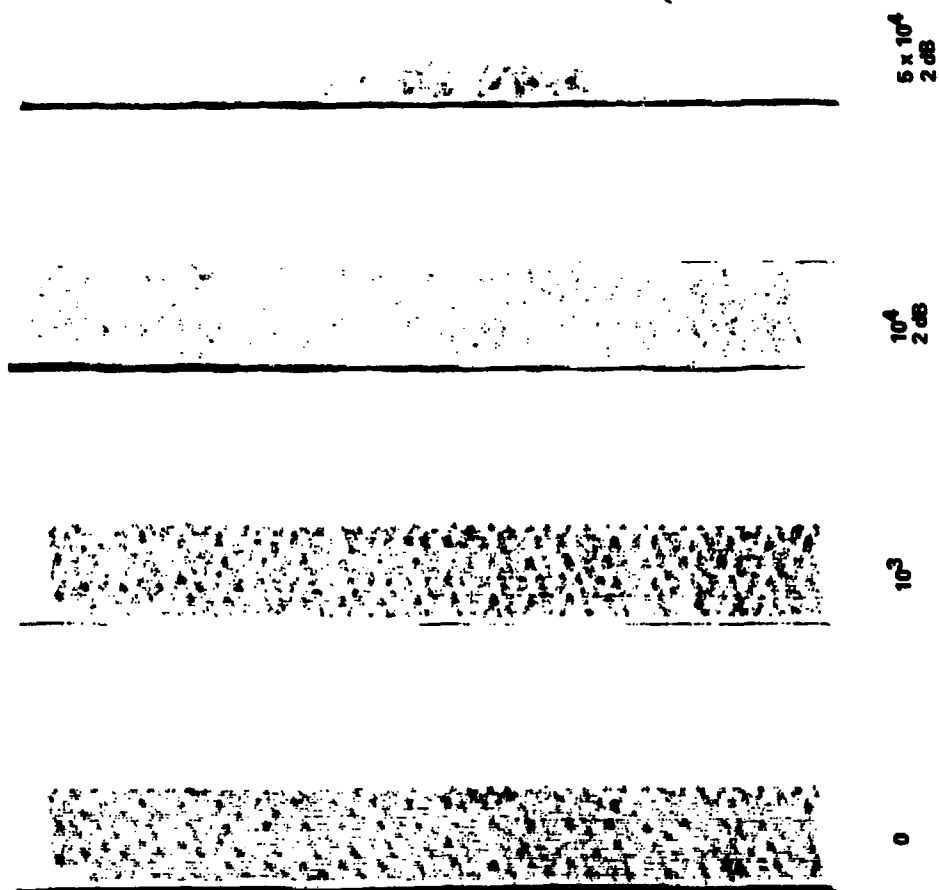
Fig 4 Ultrasonic C-scans of a woven plain coupon with layup A (0/90) tested in tensile fatigue at the stress level giving a mean life of 100000 cycles. Left to right, scans after: 0 cycles at 1 dB steps, 1000 cycles at 1 dB steps, 10000 cycles at 2 dB steps, 50000 cycles at 2 dB steps

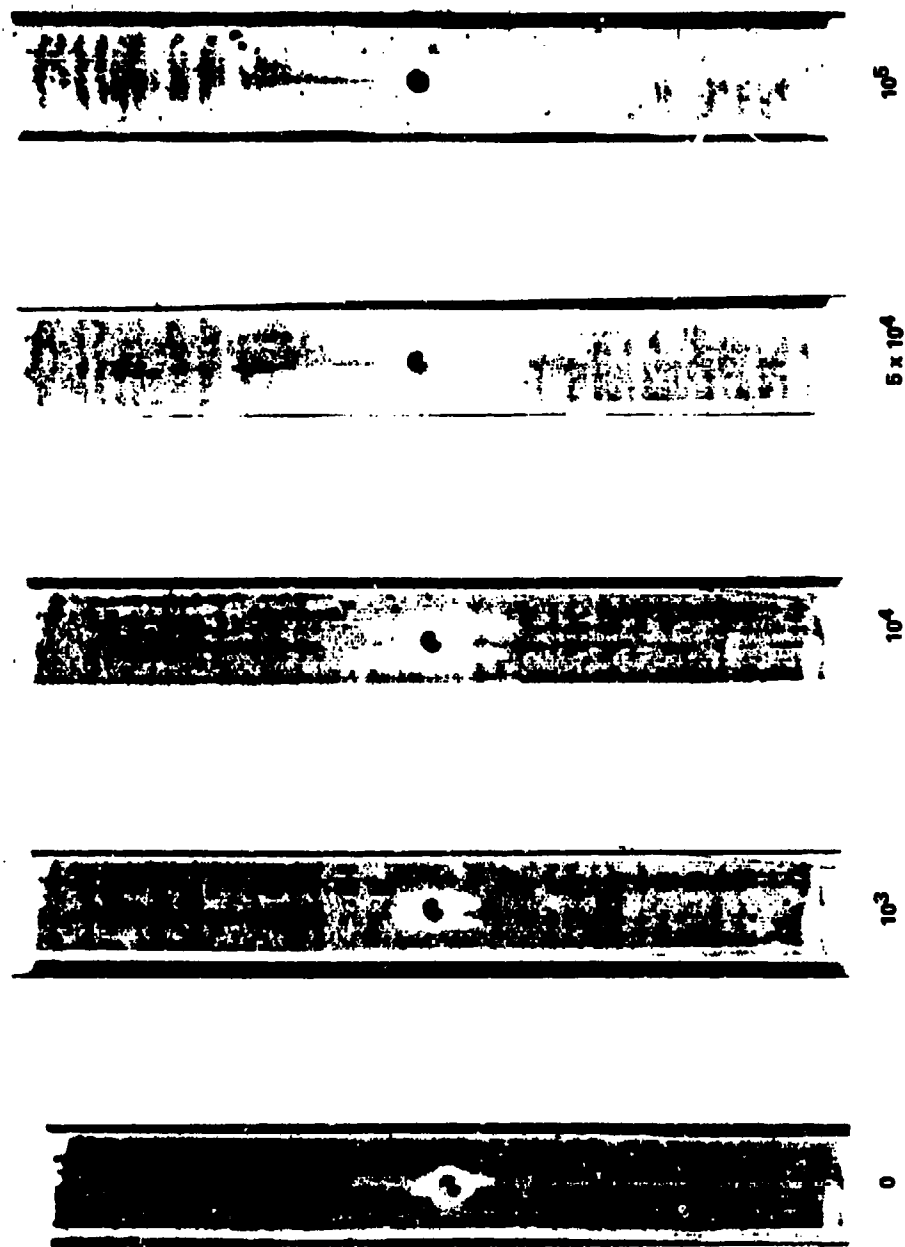
Fig 5 Ultrasonic C-scans of a non-woven holed coupon with layup A (0.90) tested in tensile fatigue at the stress level giving a mean life of 100,000 cycles. Left to right, scans after: 0 cycles at 1 dB steps, 1000 cycles at 1 dB steps, 10,000 cycles at 1 dB steps, 50,000 cycles at 1 dB steps, 100,000 cycles at 1 dB steps

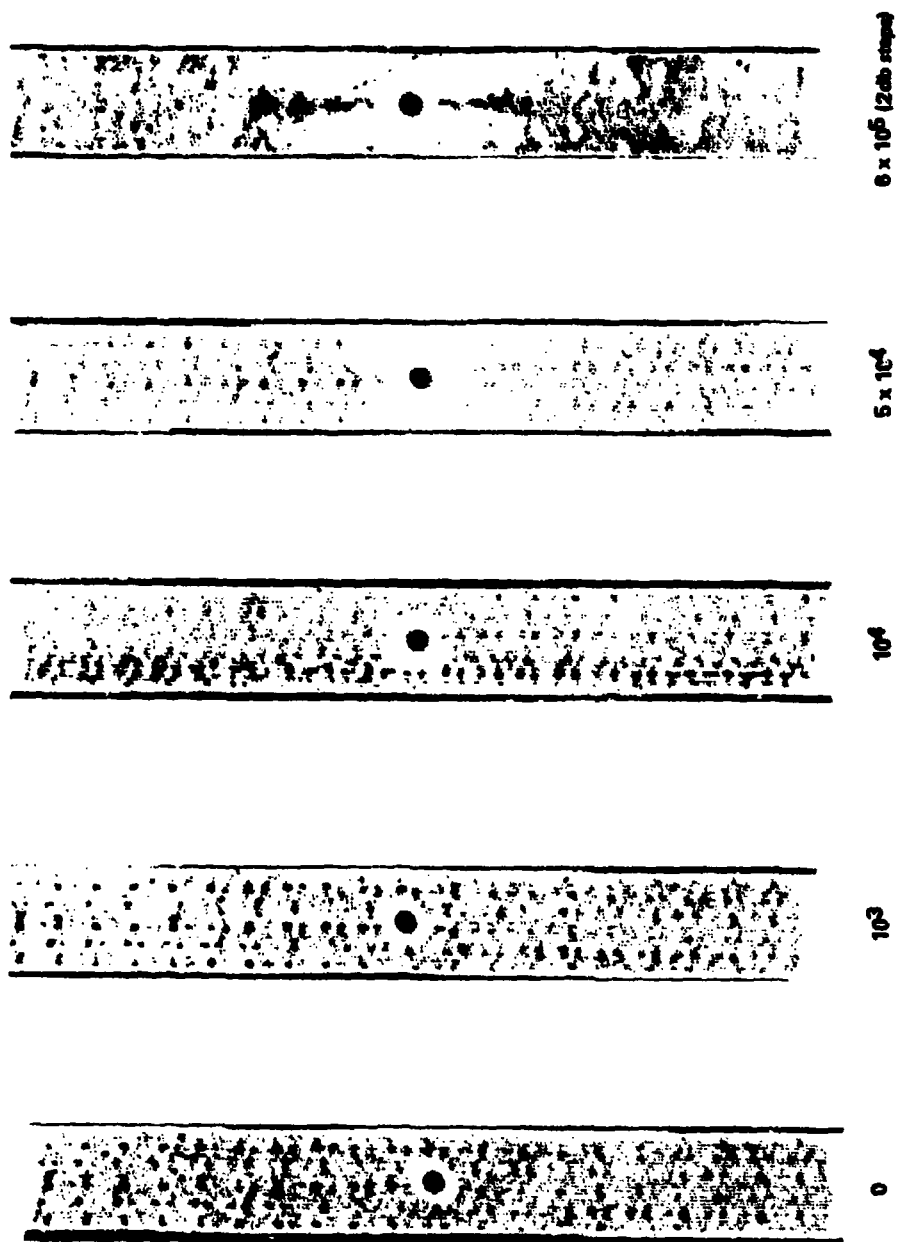
Fig 6 Ultrasonic C-scans of a woven hole coupon with layout A (0.90) tested in tensile fatigue at the stress level giving a mean life of 100000 cycles. Left to right, scans after: 0 cycles at 1 db steps, 1000 cycles at 1 db steps, 10000 cycles at 1 db steps, 50000 cycles at 1 db steps, 600000 cycles at 2 db steps

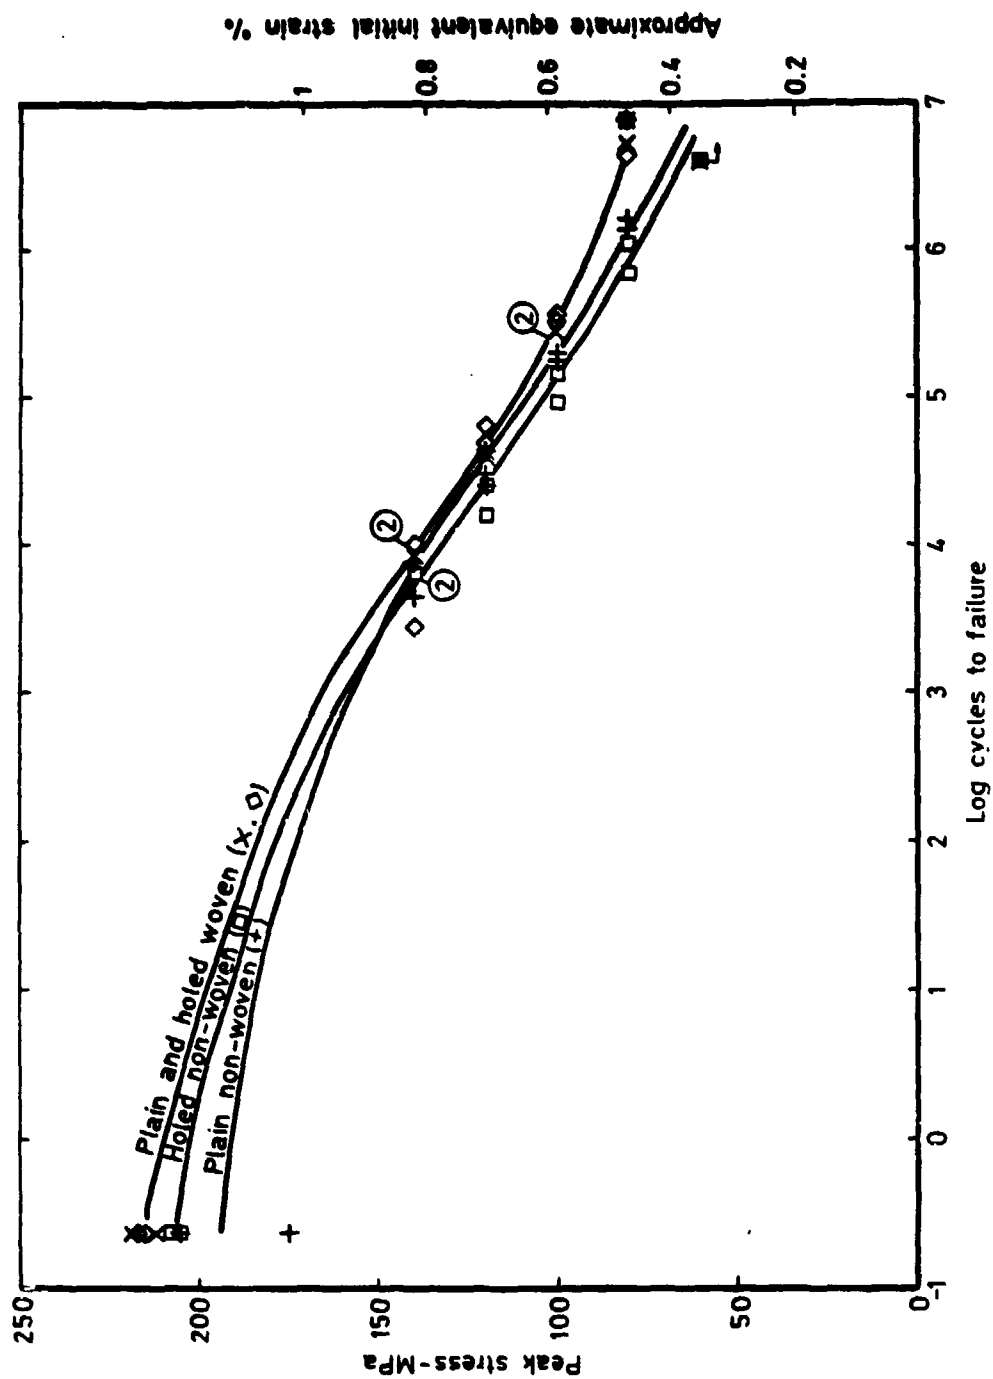
Fig 7 S-N plots of tensile fatigue data for layout B (1.45). Horizontal arrows denote run-outs

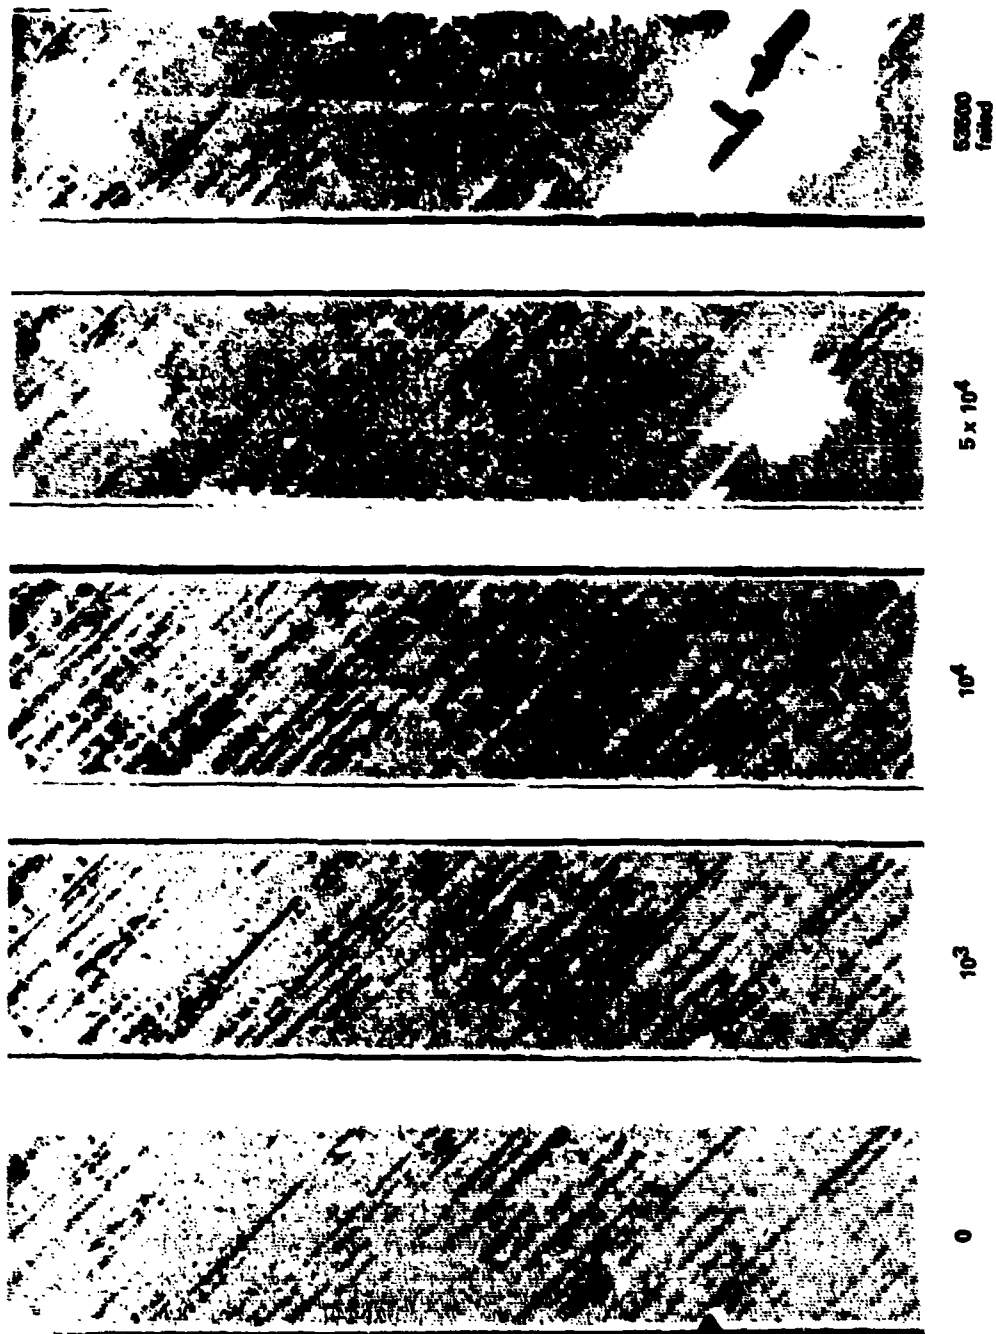
Fig 10 Ultrasonic C-scans of a non-woven plain coupon with layup B (± 45) tested in tensile fatigue at the stress level giving a mean life of 10000 cycles. Left to right, scans after: 0 cycles at 1 dB steps, 1000 cycles at 1 dB steps, 10000 cycles at 1 dB steps, 50000 cycles at 1 dB steps, 53500 cycles at 1 dB steps - failure

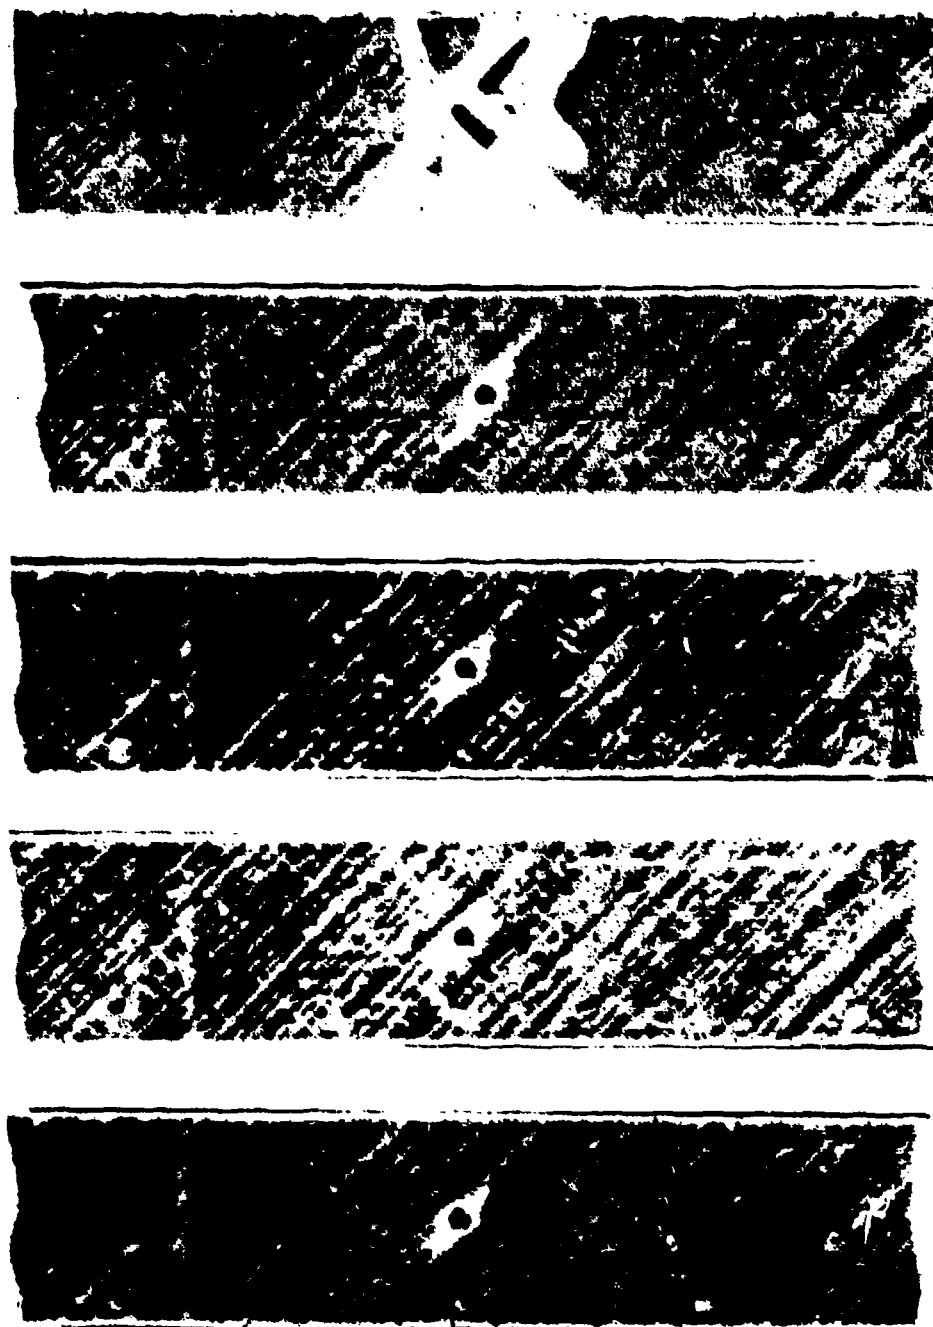
Fig 11 Ultrasonic C-scans of a non-crown holed coupon with layout B ($\pm 45^\circ$) tested in tensile fatigue at the stress level giving a mean life of 100000 cycles. Left to right, scans after: 0 cycles at 1 dB steps, 1000 cycles at 1 dB steps, 10000 cycles at 2 dB steps, 100000 cycles at 2 dB steps, 138900 cycles at 2 dB steps - failed

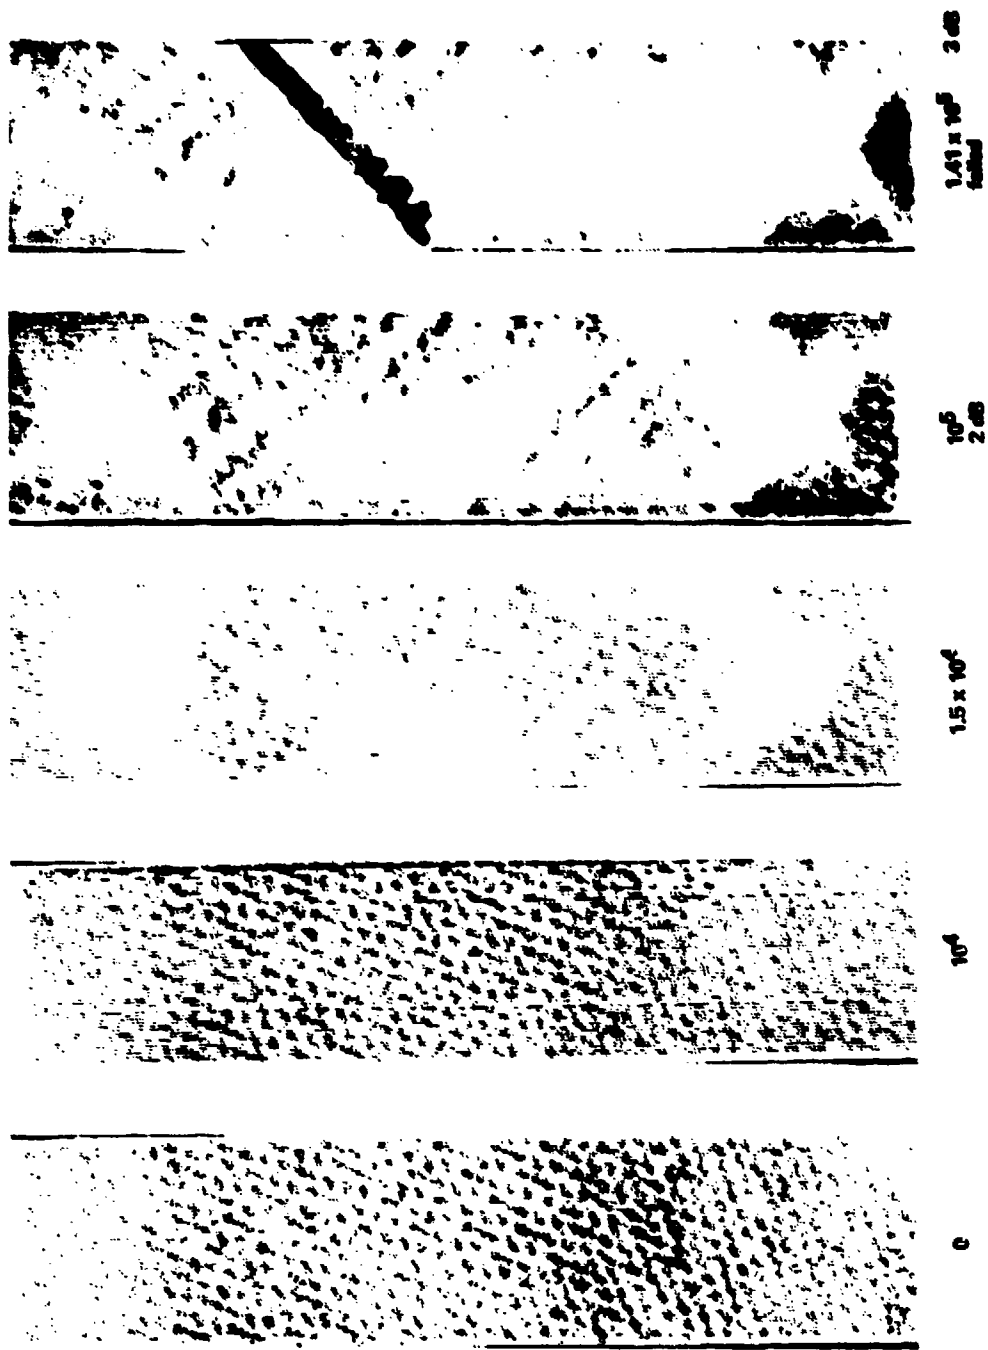
Fig 12 Ultrasonic C-scans of a woven plain coupon with layup B ($\pm 95^\circ$) tested in tensile fatigue at the stress level giving a mean life of 100000 cycles. Left to right, scans after: 0 cycles at 1 dB steps, 10000 cycles at 1 dB steps, 50000 cycles at 1 dB steps, 100000 cycles at 2 dB steps, 149000 cycles - failure at 3 dB steps

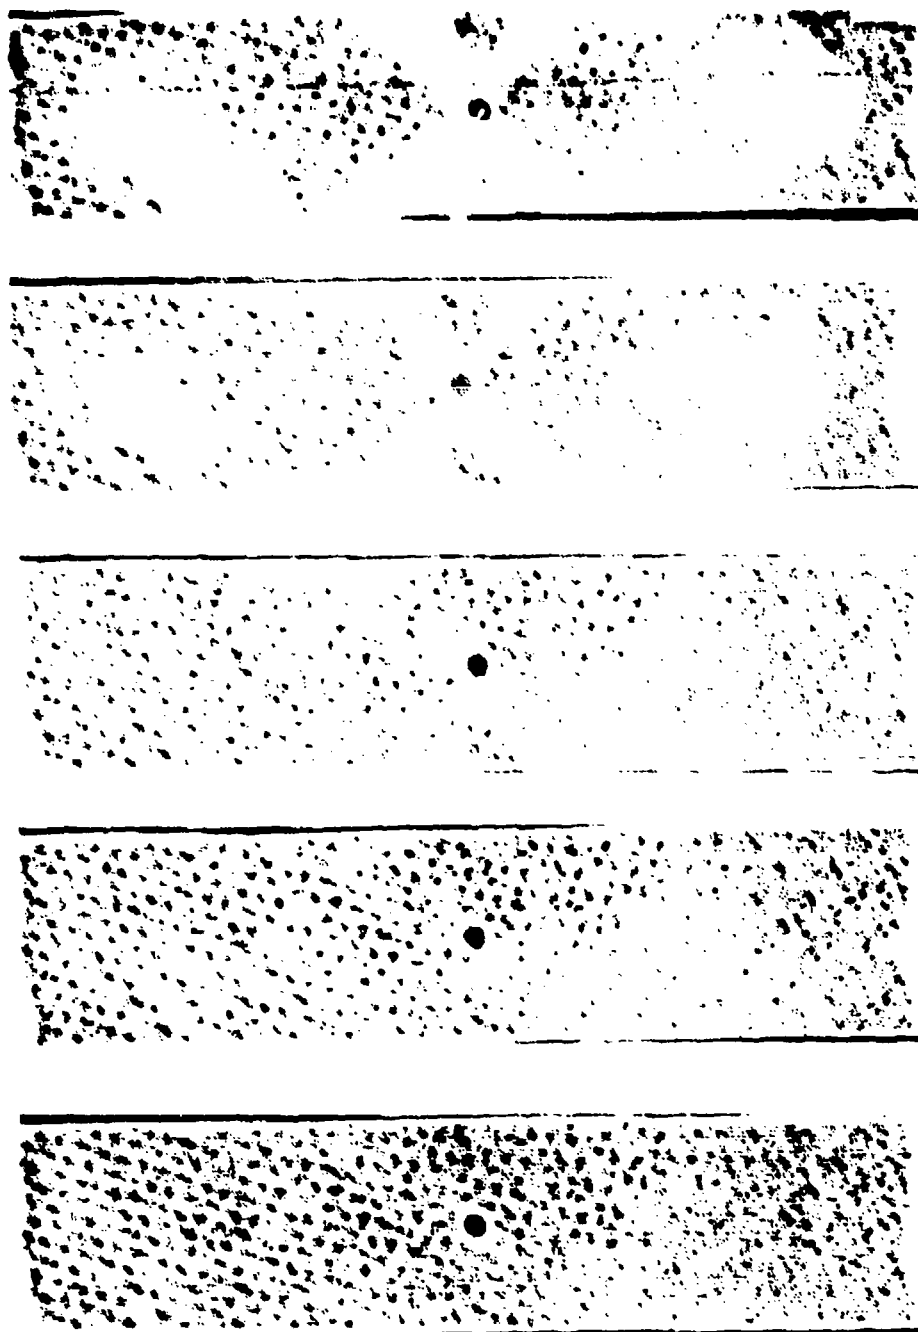
Fig 13 Ultrasonic C-scans of a woven hole coupon with layup B (± 45) tested in tensile fatigue at the stress level giving a mean life of 100000 cycles. Left to right, scans after: 0 cycles at 1 dB steps, 1000 cycles at 1 dB steps, 10000 cycles at 1 dB steps, 50000 cycles at 1 dB steps, failure

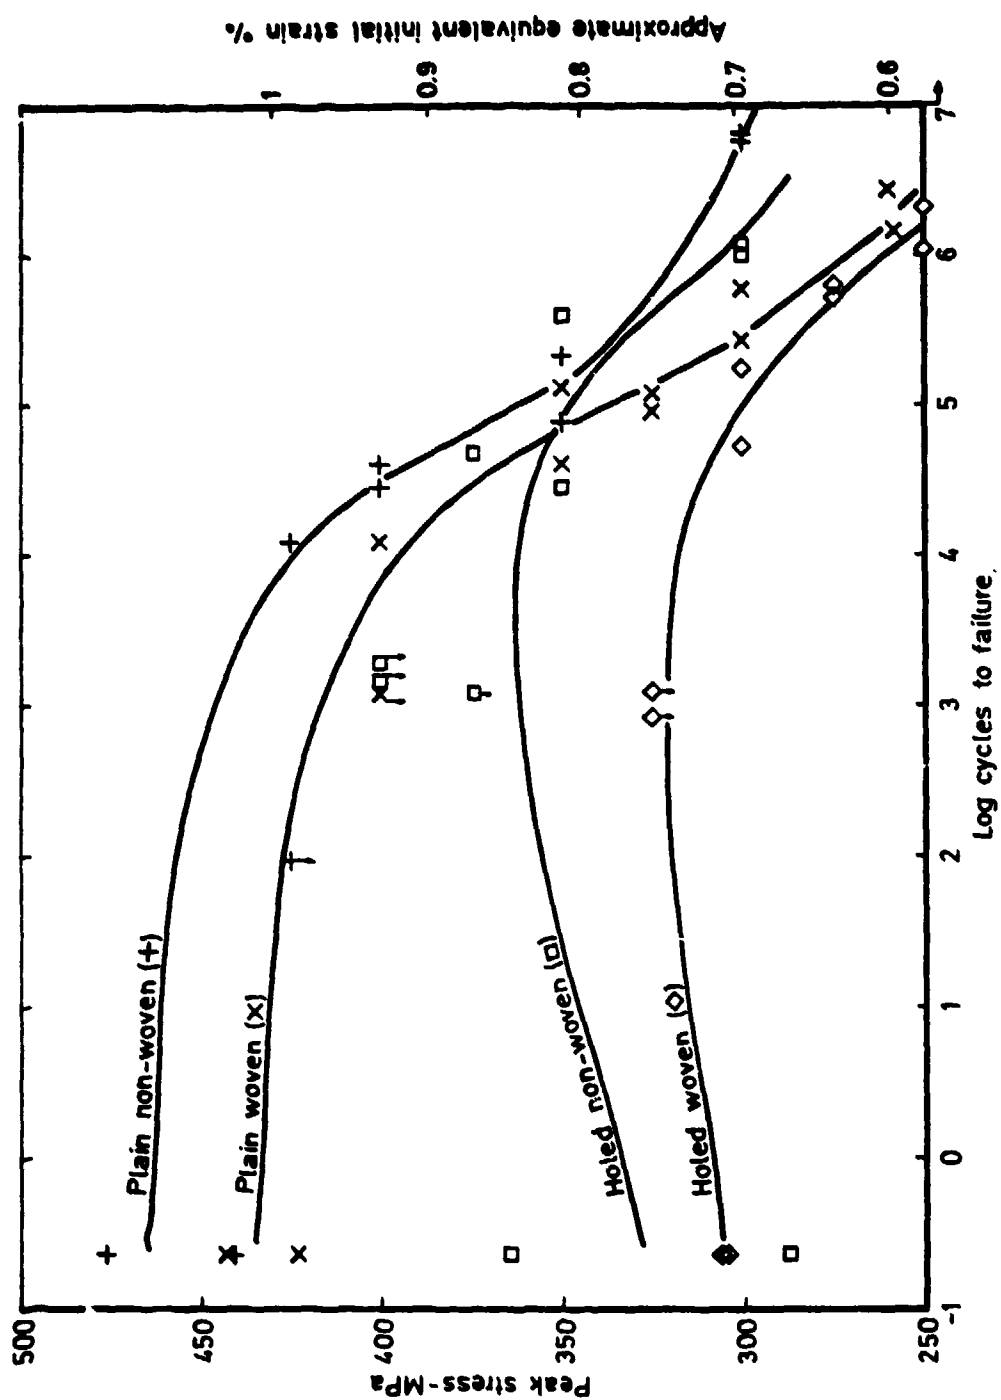
Fig 14 S-N plots of tensile fatigue data for layout C ($\pm 45,0,90$). Vertical arrows denote run-outs and horizontal arrows run-outs

Tensile fatigue tests on coupons with a ($\pm 45, 0, 90$) lay-up (lay-up C) showed a substantial loss in strength with increasing numbers of cycles, for both woven and non-woven material (Fig 14). Ultrasonic C-scanning and optical microscopy revealed extensive longitudinal edge cracking, growing from the coupon edges towards the centres of their widths, probably the cause of the significant strength losses observed. The plain woven material appeared to suffer an even greater loss in strength at high lifetimes. This implies that the static differences attributed to lower fibre volume fraction and greater fibre distortion in the woven material continued to account for the lower fatigue strength except at long lifetimes when additional strength degradation mechanisms were operative in the woven material. The microstructural analysis again revealed considerable damage at the tow crossover points in the woven material, particularly at long lifetimes, and this undoubtedly resulted in a further reduction in the load bearing capacity of the 0° tows. This caused an additional loss in strength compared with the non-woven material in which the 0° and 90° plies became uncoupled and the stress concentrating effects of the 90° plies on the 0° plies relieved.

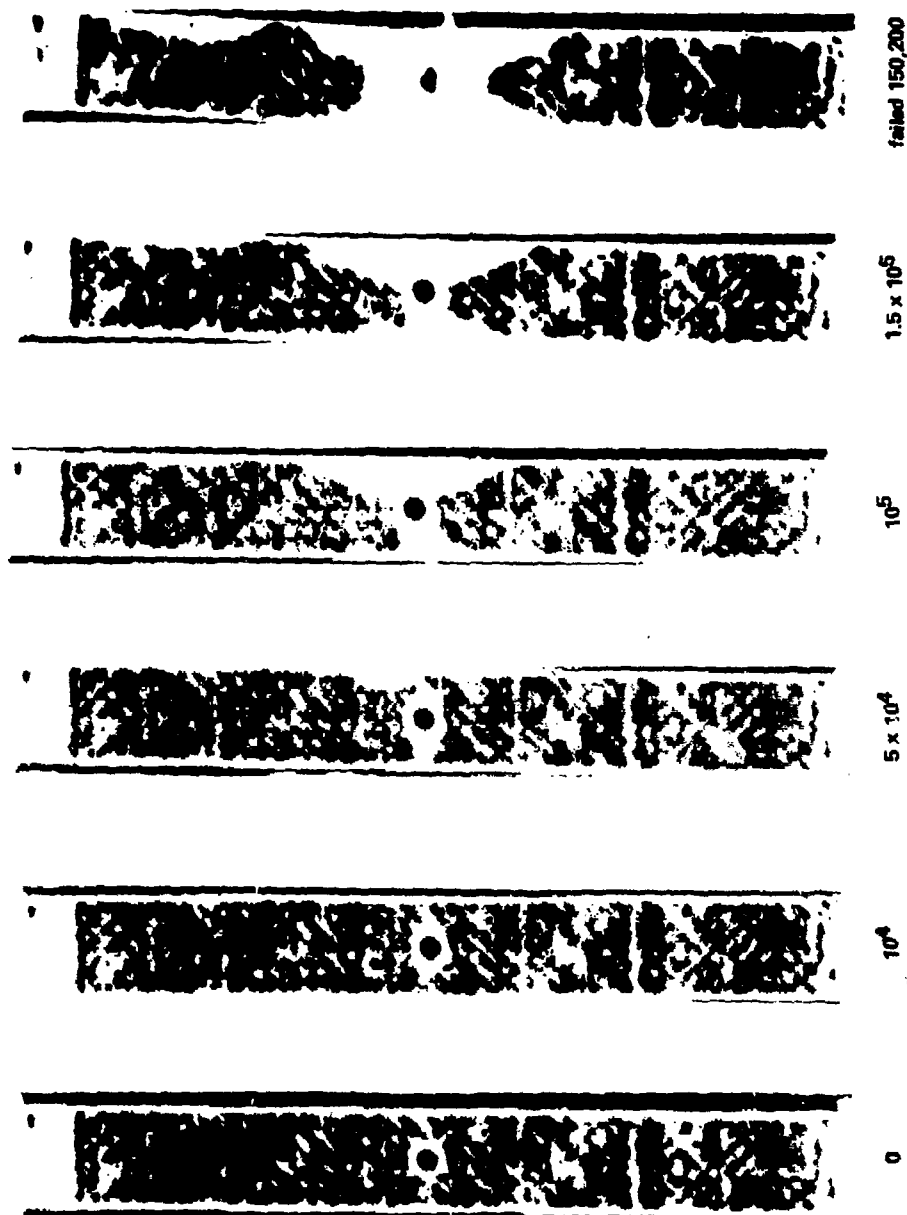
Fig 18 Ultrasonic C-scans of a non-woven holed coupon with $\log_{10} C (\pm 45, 0.90)$ tested in tensile fatigue at the stress level giving a mean life of 100,000 cycles. Left to right, scans after: 0 cycles at 1 dB steps, 10,000 cycles at 1 dB steps, 50,000 cycles at 1 dB steps, 100,000 cycles at 1 dB steps, 150,000 cycles at 1 dB steps, 150,200 cycles — failure, at 1 dB steps

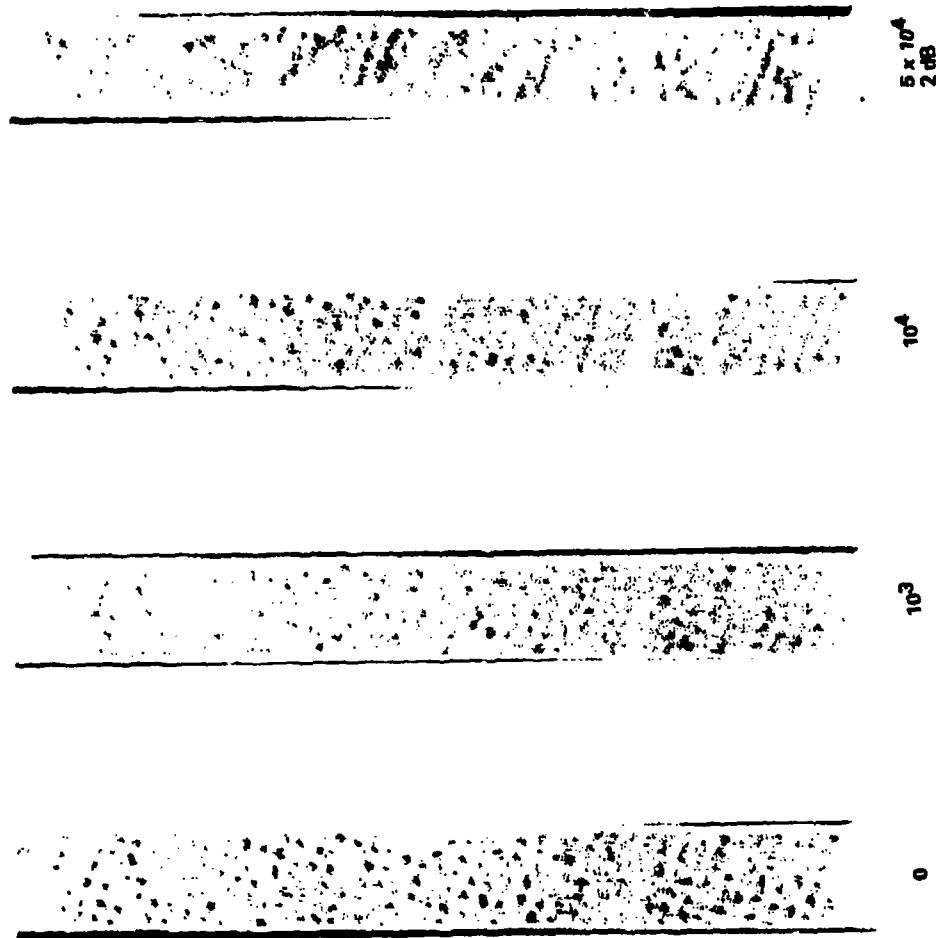
Fig 19 Ultrasonic C-scans of a woven plain coupon with layout C ($\pm 45, 0, 90$) tested in transverse fatigue at the stress level giving a mean life of 100000 cycles. Left to right, scans after: 0 cycles at 1 dB steps, 10000 cycles at 1 dB steps, 50000 cycles at 2 dB steps

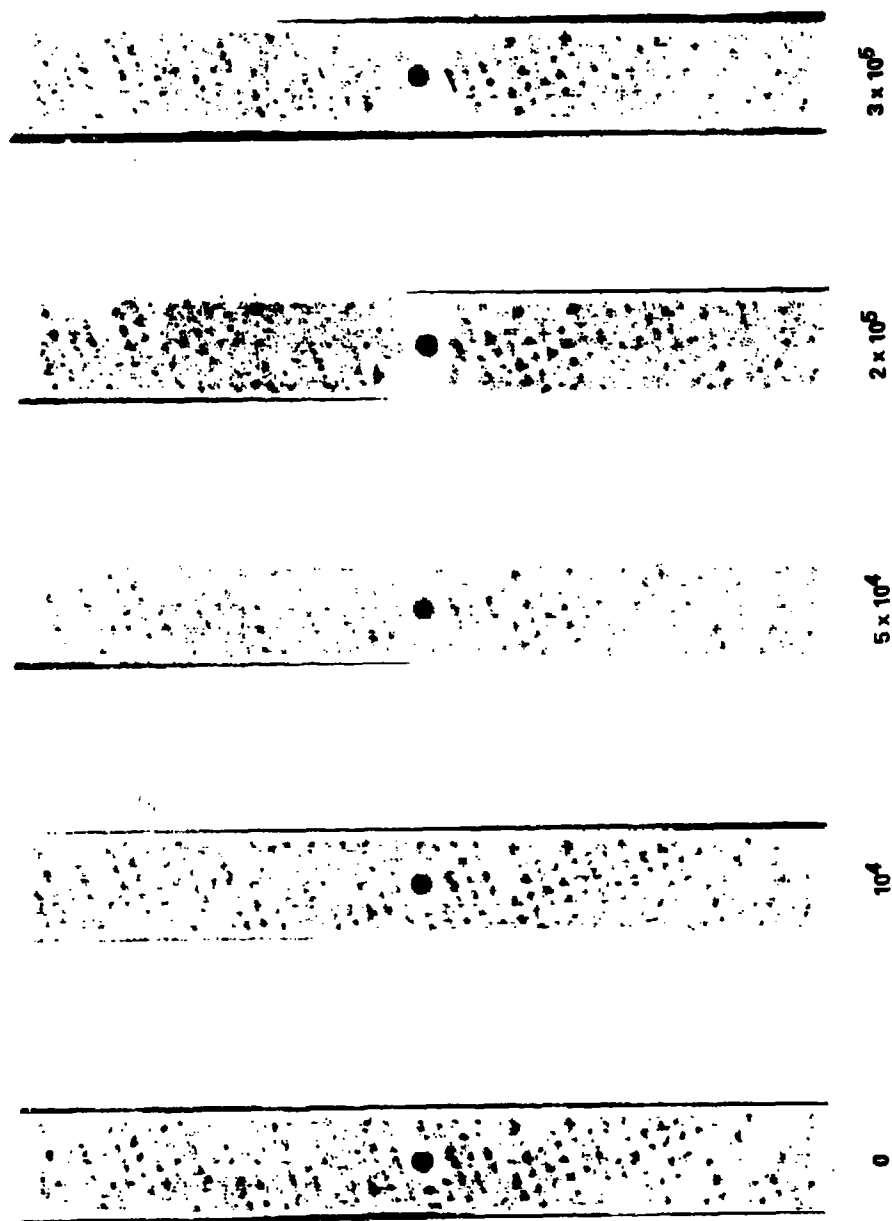
Fig 20 Ultrasonic C-scans of a woven holed coupon with layup C ($\pm 45,0,90$) tested in tensile fatigue at the stress level giving a mean life of 100000 cycles. Left to right, scans after: 0 cycles at 1 dB steps, 10000 cycles at 1 dB steps, 50000 cycles at 1 dB steps, 200000 cycles at 1 dB steps, 300000 cycles at 1 dB steps

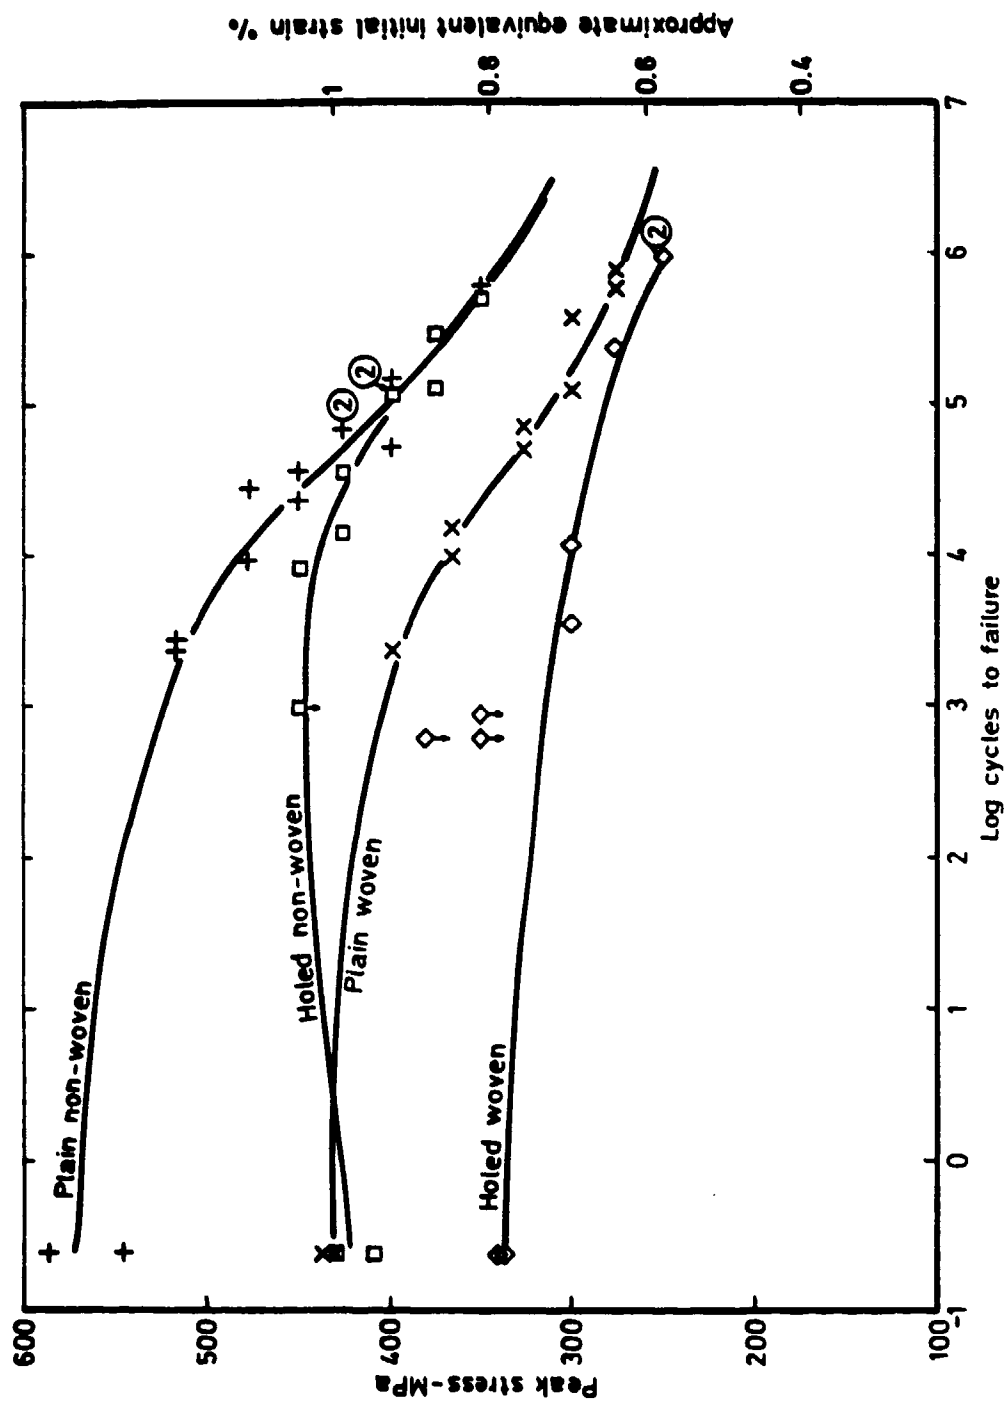
Fig 21 S-N plots of tensile fatigue data for layup D (0,90,45). Optical arrows denote run up failures

Results of the fatigue tests are given in Table 9 and also as a plot of peak net stress versus log-life (S-N plot) in Fig 21. Plain coupons all failed at random positions

Coupons with the ($0, 90, \pm 45$) lay-up (lay-up D) also showed a significant loss in strength with increasing numbers of tensile fatigue cycles (Fig 21). Microstructural analysis revealed less extensive longitudinal edge cracking than in lay-up C, but transverse cracks were formed across the 90° plies and initiated some layer delamination at large numbers of cycles. Considerable damage was also developed in the $\pm 45^\circ$ layers adding to the loss in strength observed. The strength of the woven material remained a similar fraction of that of the non-woven material even up to 1 million fatigue cycles. This implies that the principal cause for the difference between the strength of the plain woven and non-woven material remained greater fibre distortion and lower fibre volume fraction. This is somewhat surprising since the microstructural analysis revealed, as in coupons with lay-up C, the development of significant damage at the tow crossover points in the woven material after large numbers of fatigue cycles. The effect

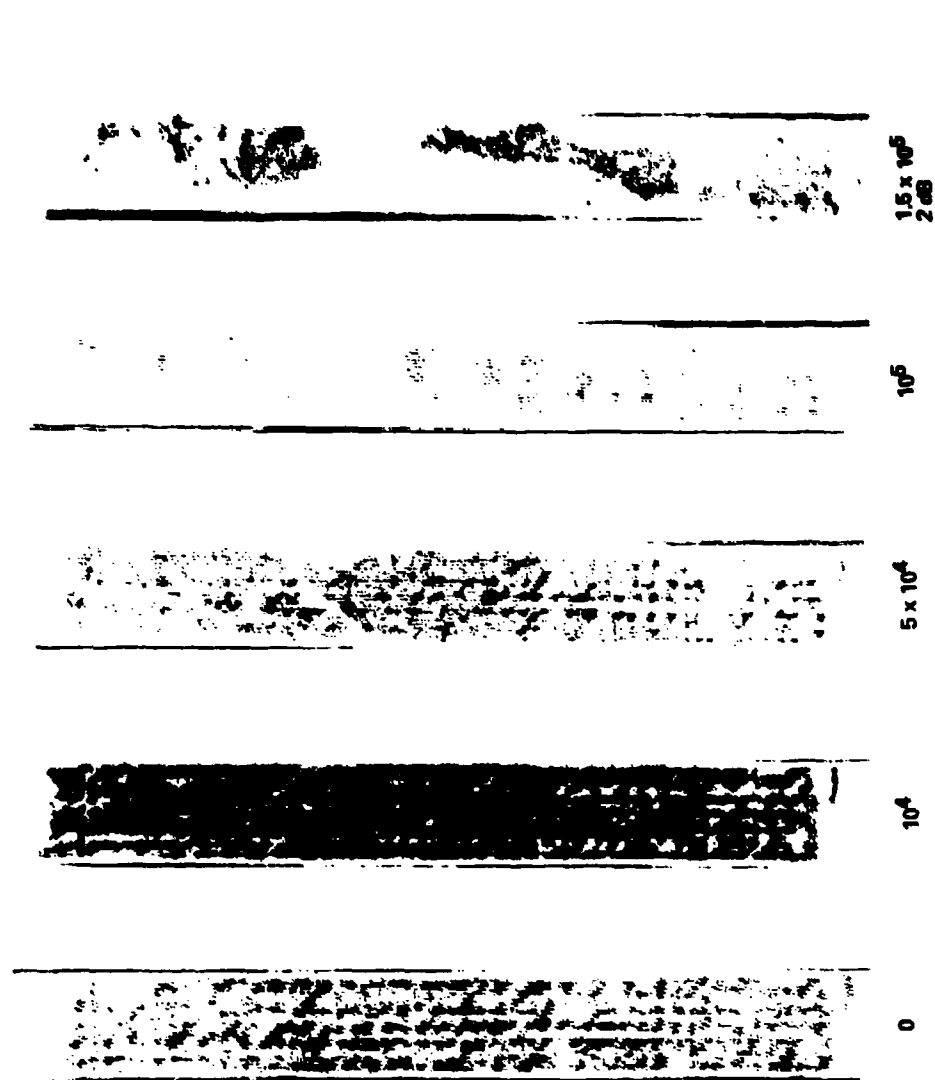
Fig 24 Ultrasonic C-scans of a non-woven plain coupon with layup D (0.90, ± 45) tested in tensile fatigue at the stress level giving a mean life of 100000 cycles. Left to right, scans after: 0 cycles at 1 dB steps, 10000 cycles at 1 dB steps, 50000 cycles at 1 dB steps, 100000 cycles at 1 dB steps, 150000 cycles at 2 dB steps
